# Debris/Ice/TPS Assessment and Integrated Photographic Analysis of Shuttle Mission STS-66

**DEBRIS/ICE/TPS ASSESSMENT  
AND  
INTEGRATED PHOTOGRAPHIC ANALYSIS  
OF  
SHUTTLE MISSION STS-66**

**3 November 1994**

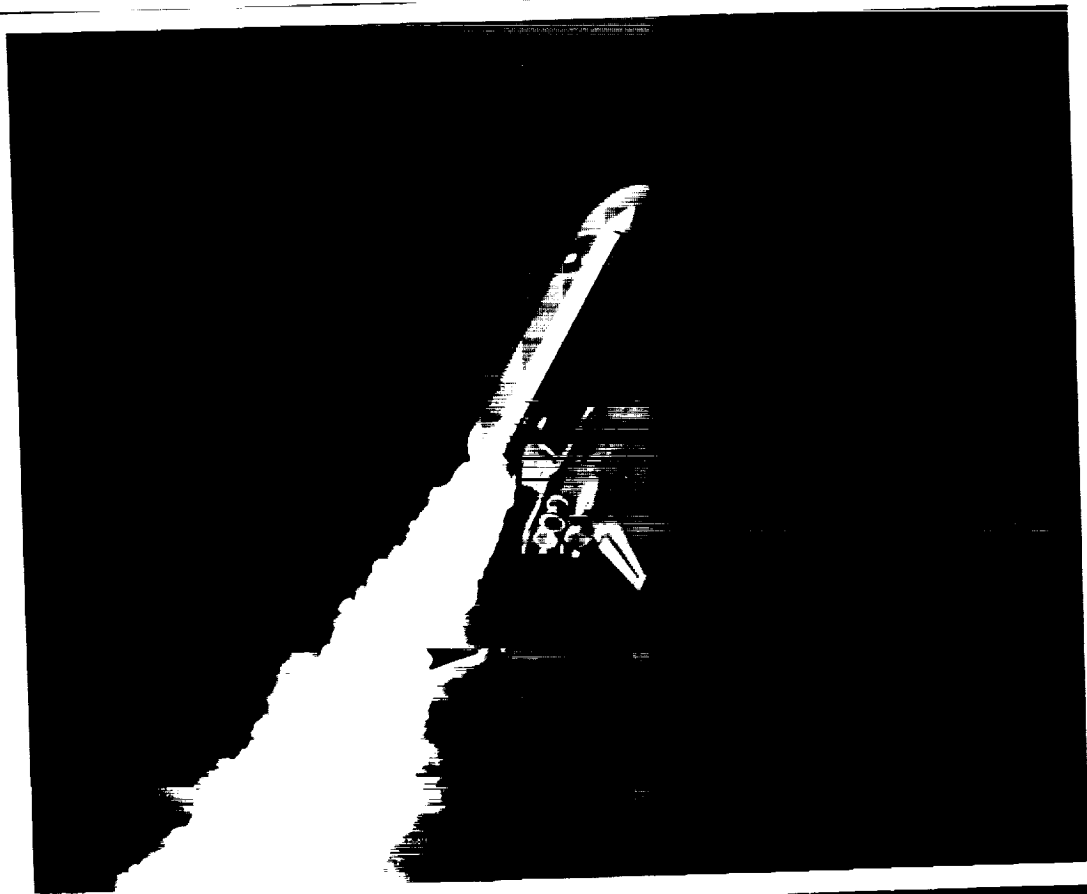
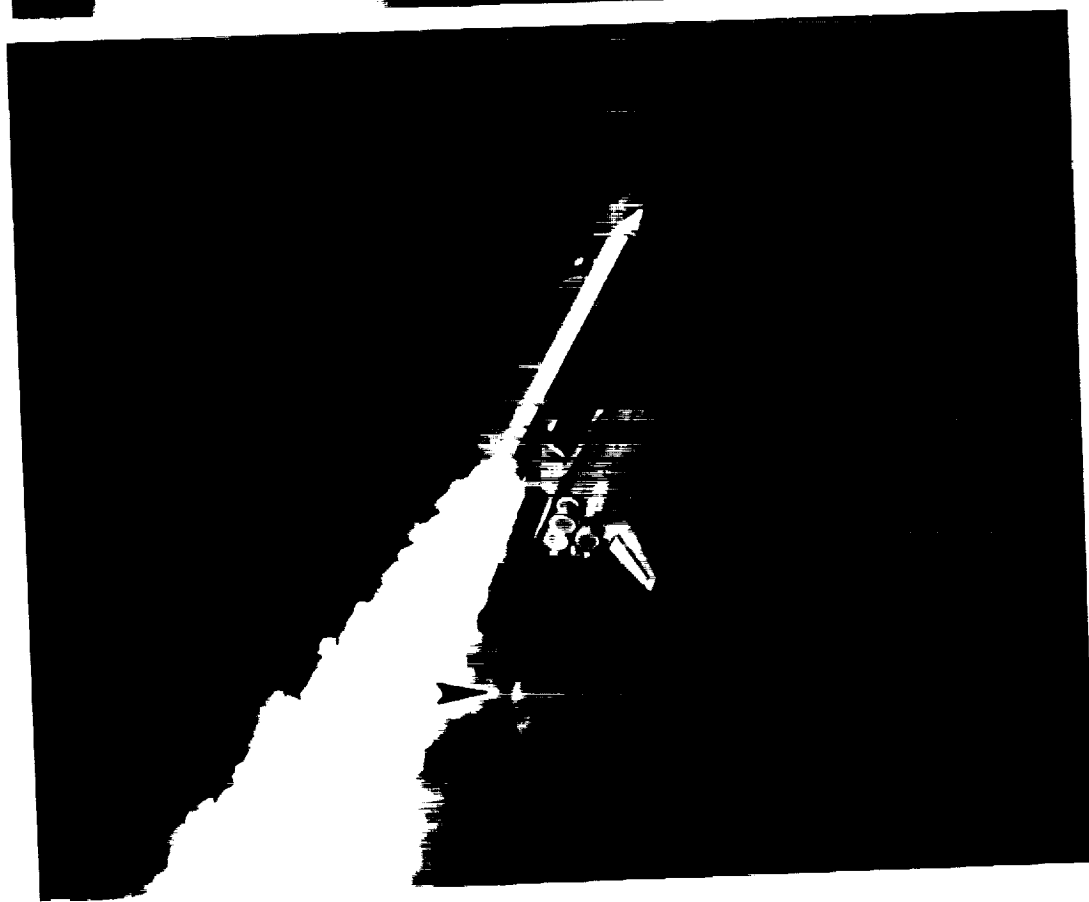
**Photo 7 : Flash in SSME Plume Caused by Debris**

Typical sequence shows debris, such as ET/ORB umbilical purge barrier material or RCS thruster paper cover, falling into SSME exhaust plume and causing an orange flash (arrows)

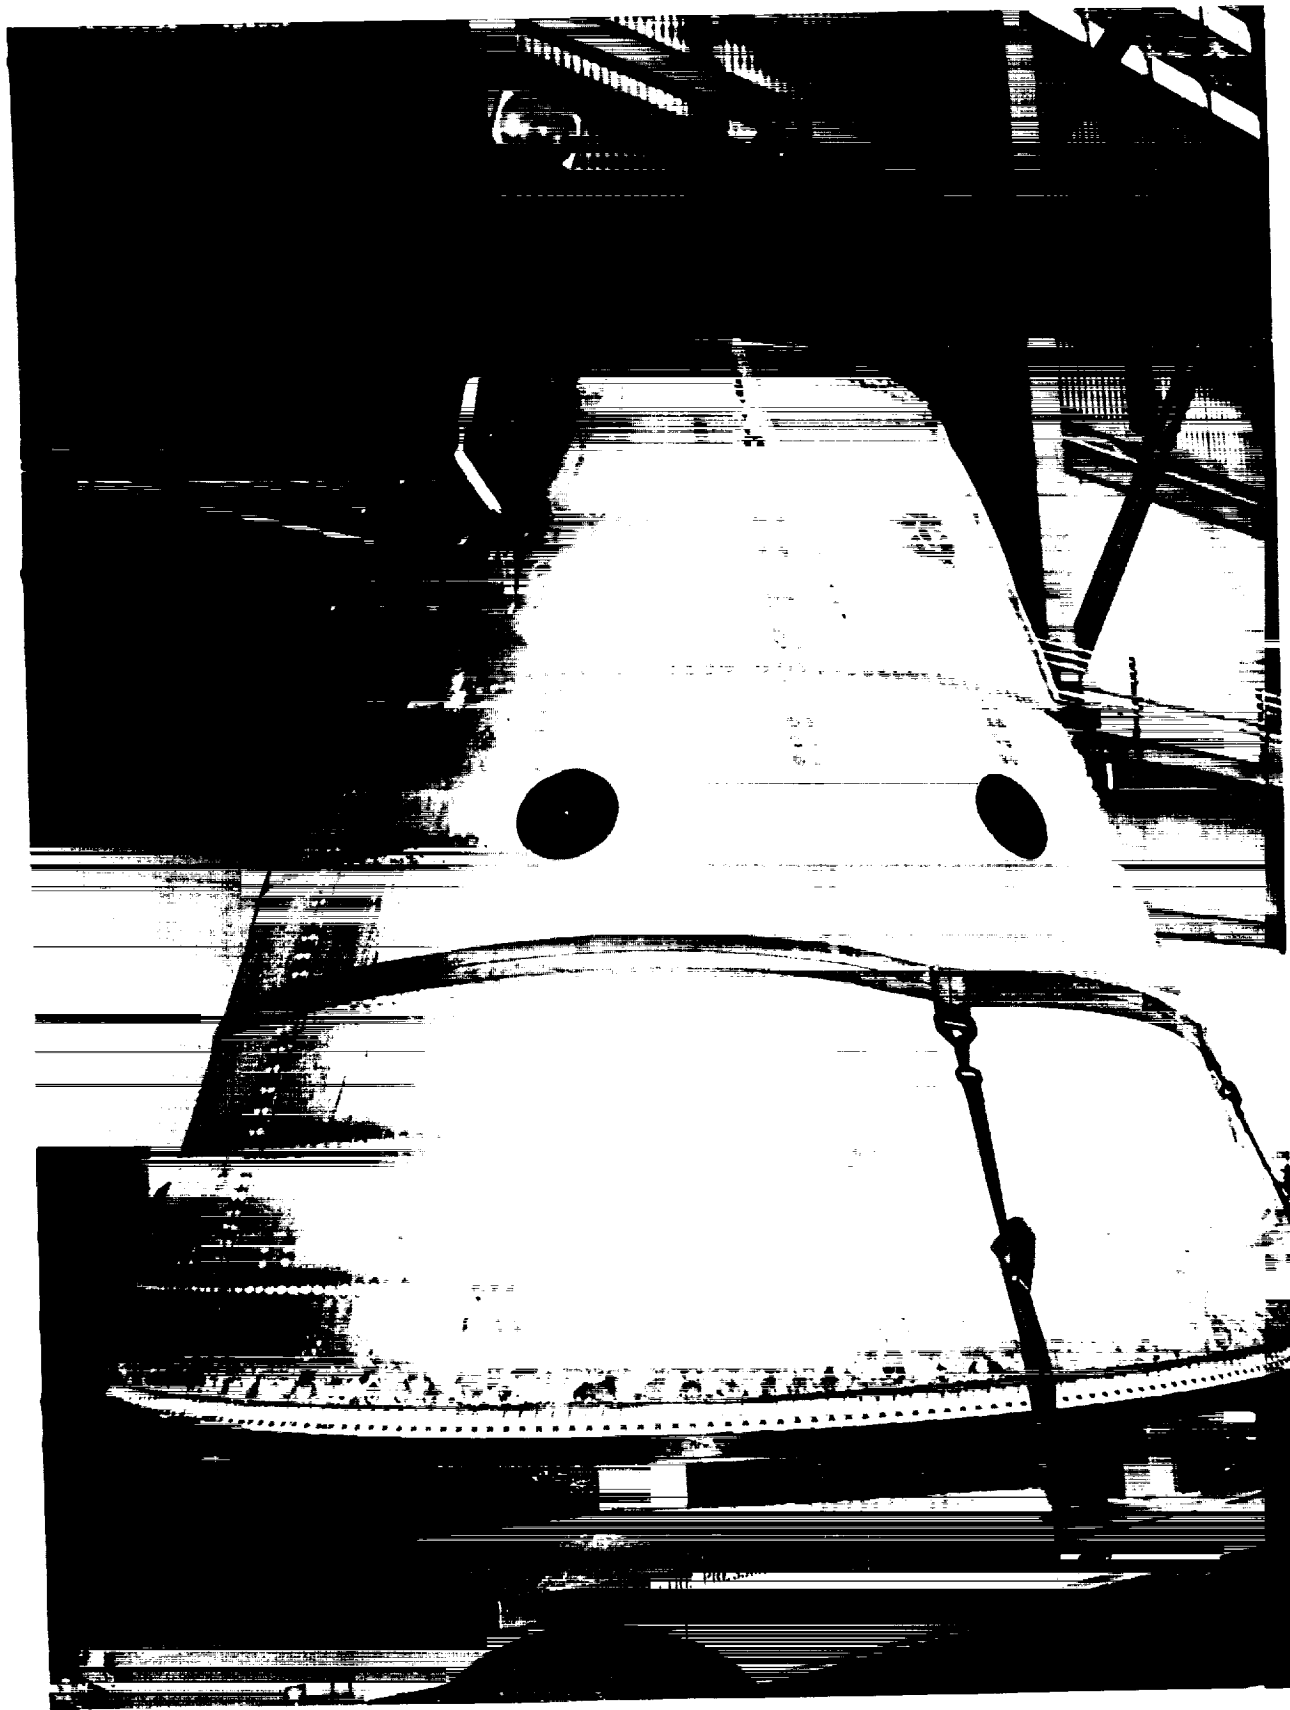
**Photo 15 : RH Frustum**

The RH frustum was missing no TPS but had 50 MSA-2 debonds over fasteners and 2 debonds over acreage. The BSM aero heat shield covers had locked in the fully opened position.

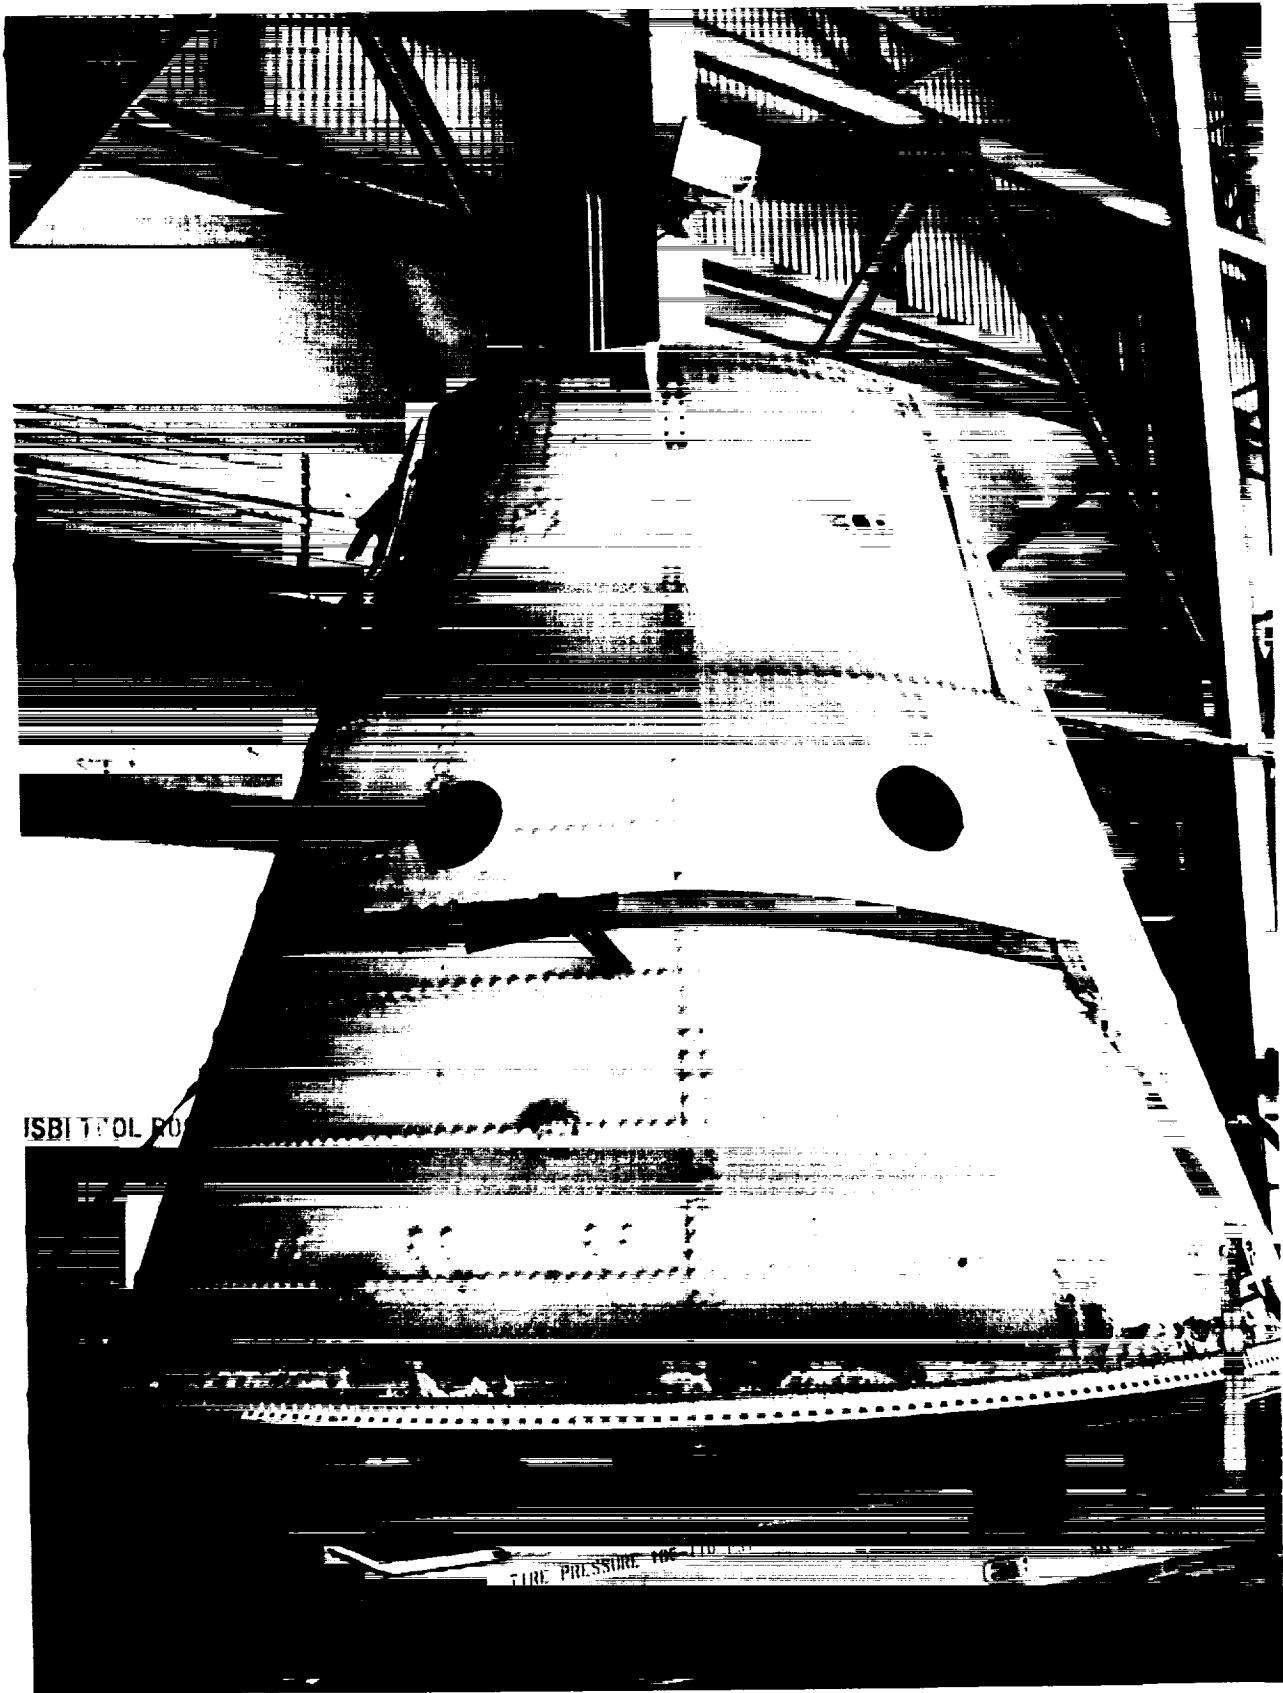
**Photo 18 : LH Frustum**

The LH frustum was missing no TPS but had 39 MSA-2 debonds over fasteners. Hypalon paint was blistered/missing where BTA closeouts had been applied. All BSM aero heat shield covers had locked in the fully opened position.

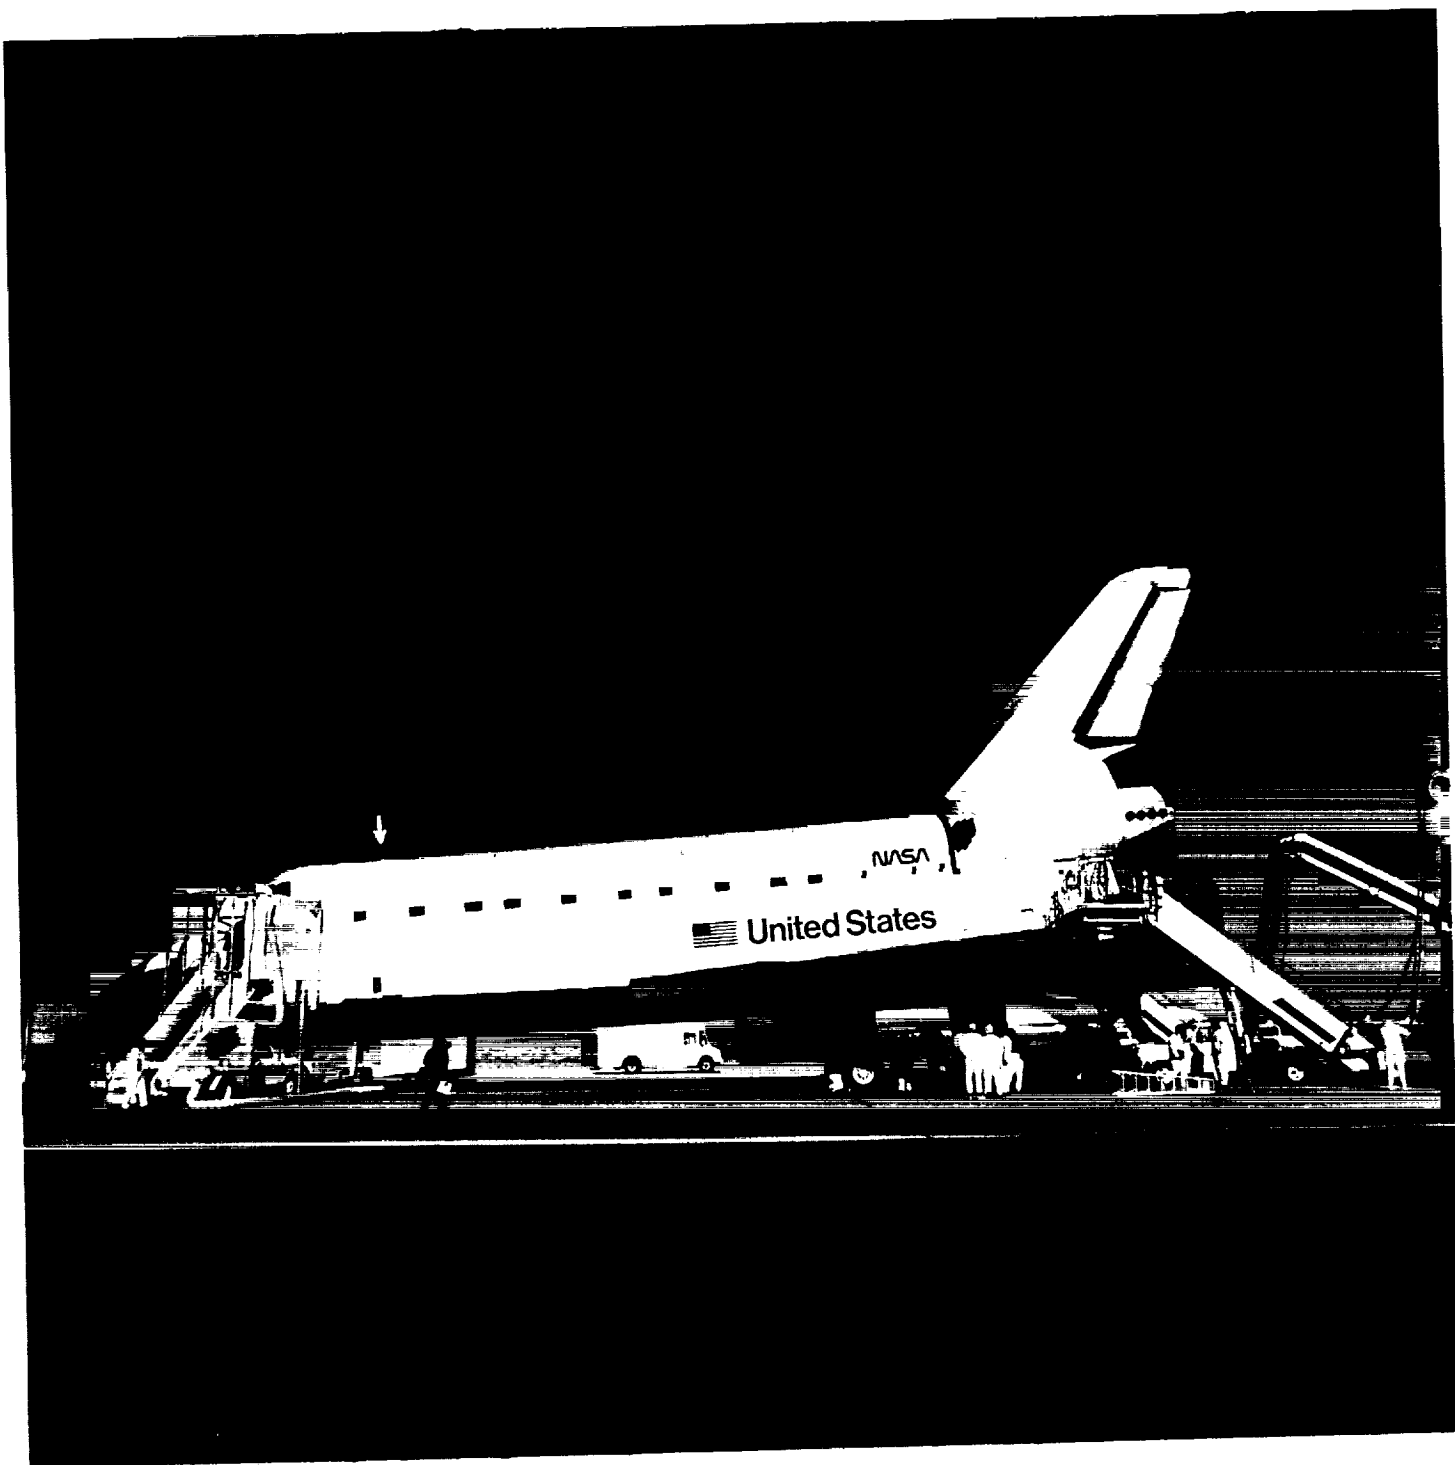
**Photo 22 : Overall View of Orbiter Left Side**  
Note ice still attached to left payload bay door (arrow)

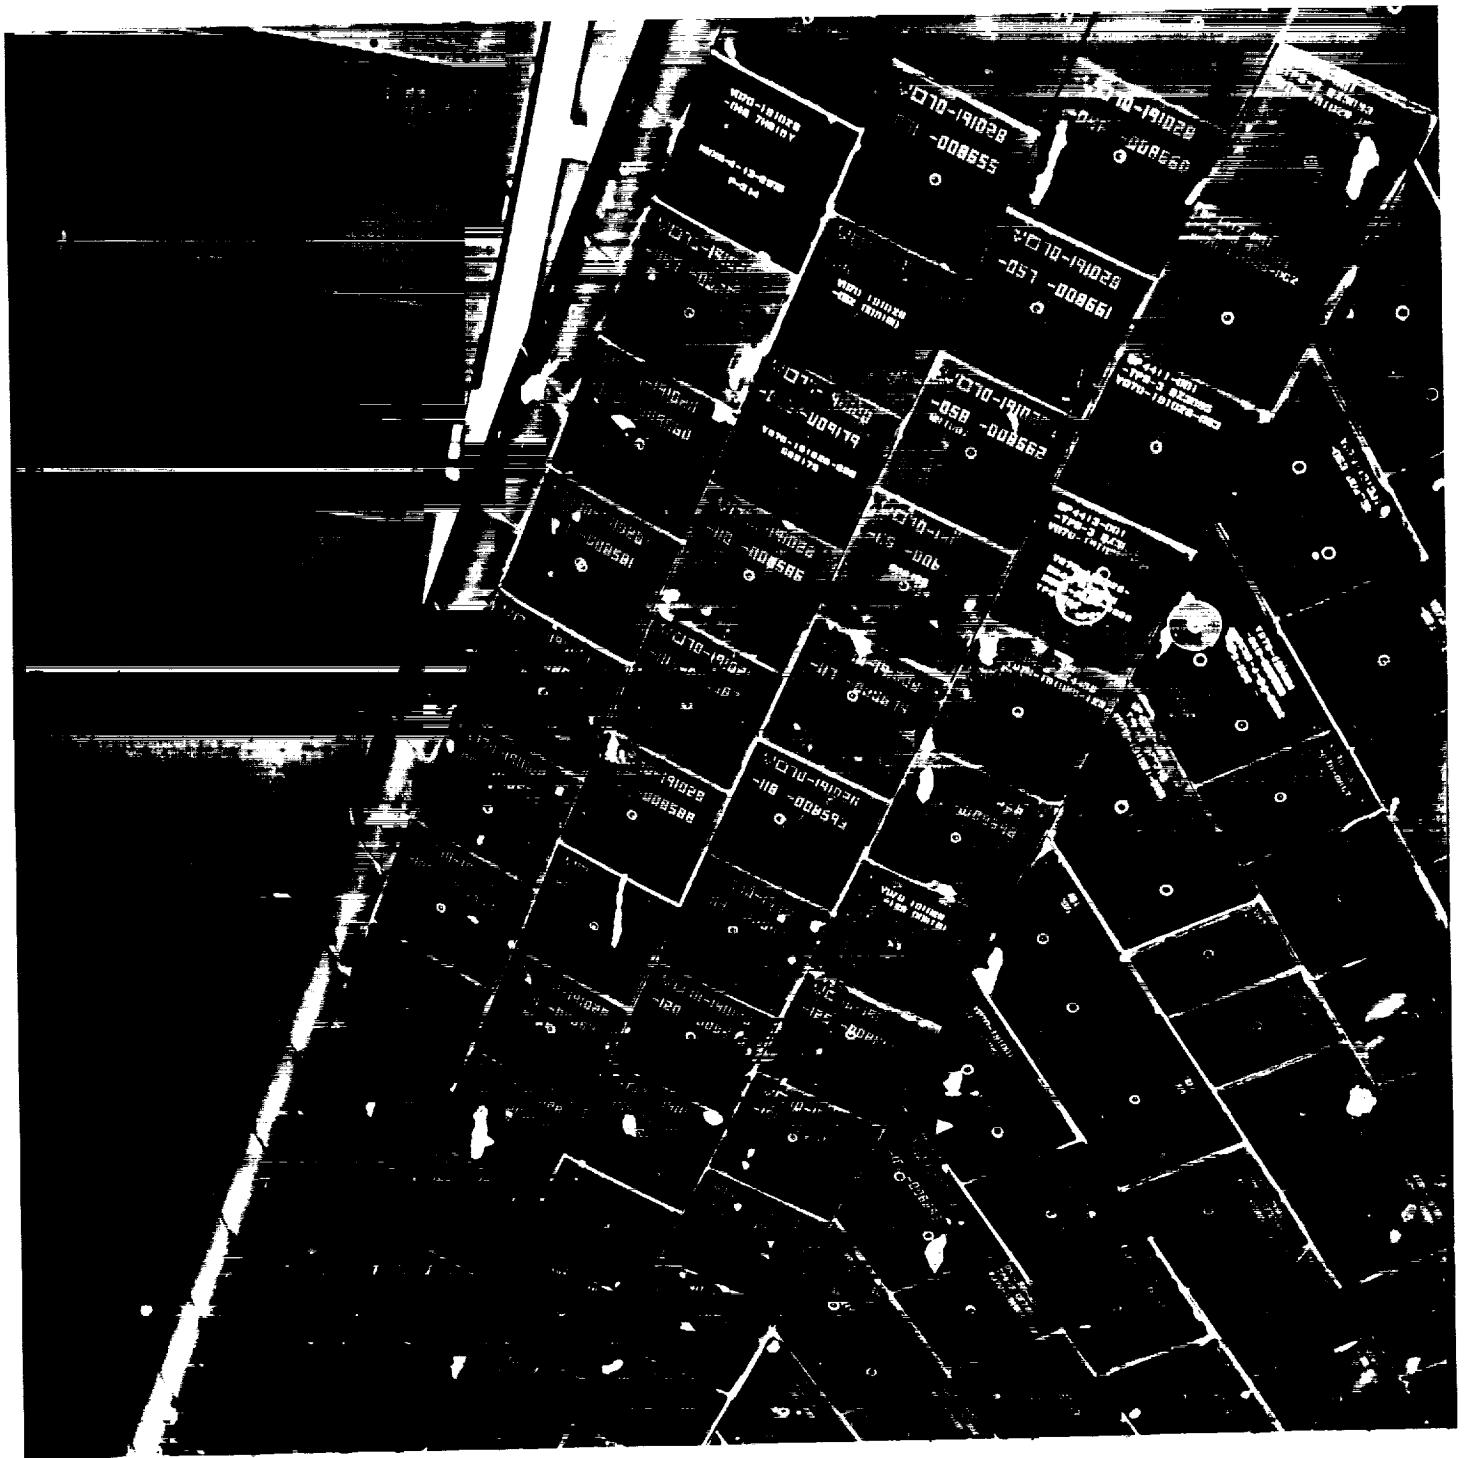
**Photo 24 : Lower Surface Tile Damage**

The Orbiter lower surface sustained a total of 111 hits, of which 22 had a major dimension of 1-inch or larger. This view includes the lower right side/chine area.

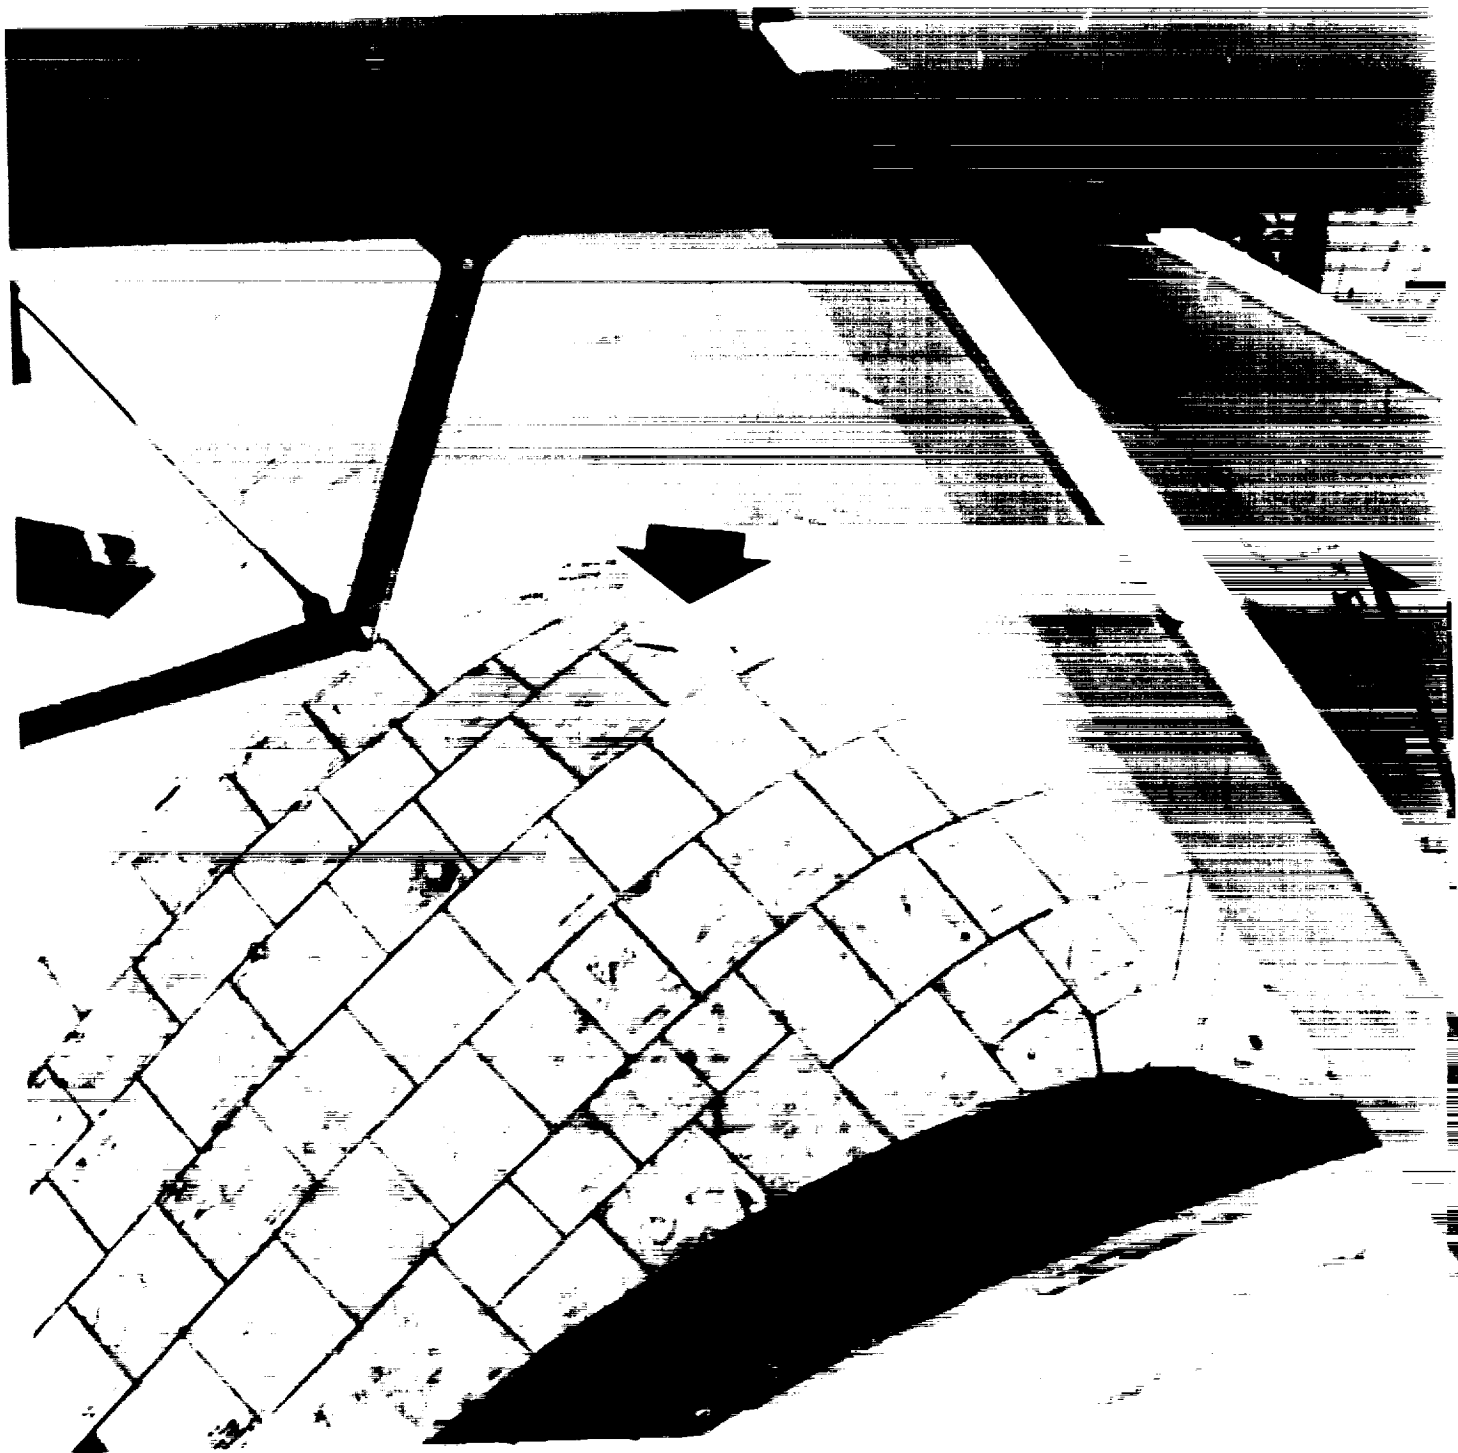
**Photo 27 : RH OMS Pod Tile Damage**

Pieces of ice from the payload bay door falling aft during reentry are believed to be the cause of the tile damage on the right OMS pod

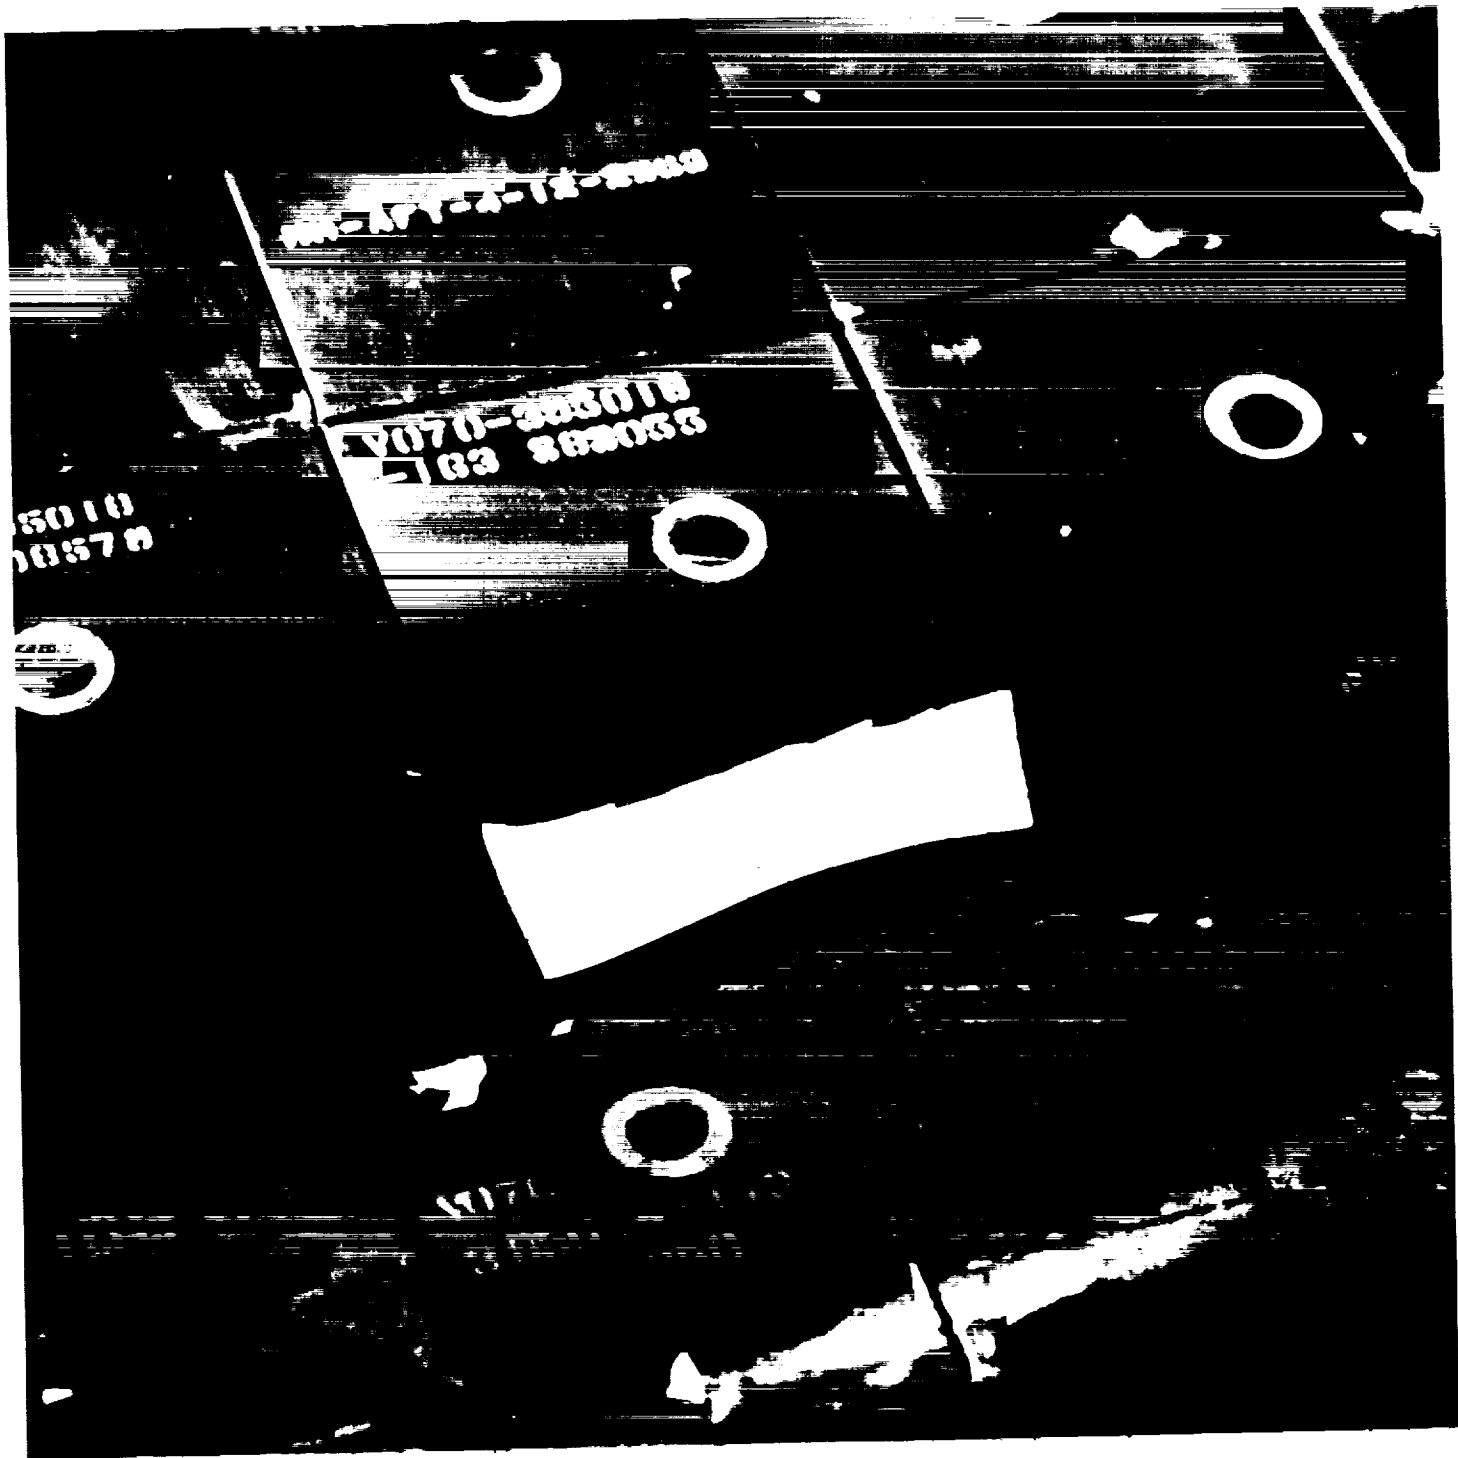
**Photo 35 : Body Flap Stub Tile Damage**

A 2 inch by 1 inch by 1 inch thick portion of an aft perimeter tile on window #8 was missing and was the subject of an IFA because of a similar occurrence on the previous mission, STS-68.

The aft quarter of a body flap stub tile was missing from the +Z side of the body flap below and outboard of SSME #2. The black tile fragment had shaken loose during SSME ignition and was observed falling into the SSME exhaust hole during the launch film review.
